# **Mount Baker Key Community Theatre**

## **ASSESSMENT REPORT**

**April 2011**

**WFE Project No: 11-15929**

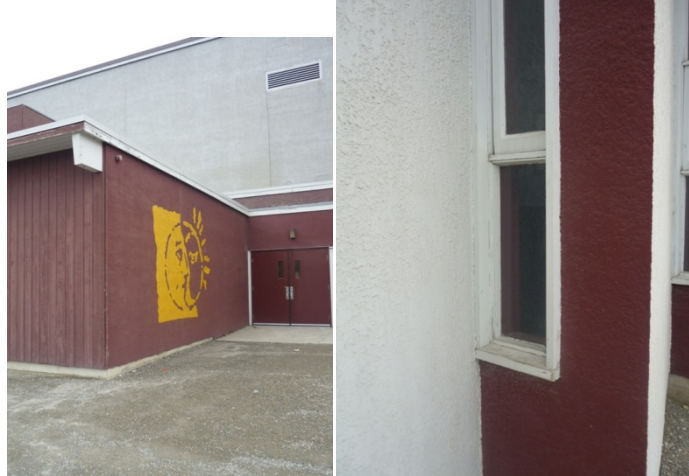
Most of the west wall are primarily stucco clad wood frame, with its lower portions clad with vertical wood siding. We noted that these walls, as well as the wood windows there are badly weathered and worn. Replacement and improvement are recommended, Refer to EPC # 4 Estimated Probable Costs as appended at the end of the report.

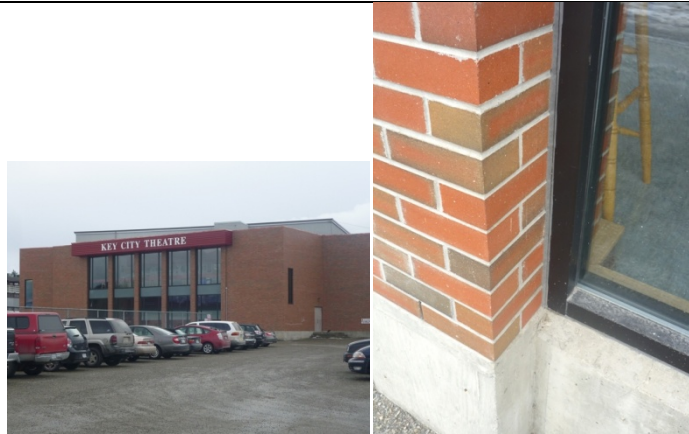
The existing glazed wall - with sealed double glazed units in aluminum frame is in reasonably good shape. Similarly with the brick clad portions of the wall. To improve energy usage both in winter and during the summer, replacement of all the windows with thermally broken aluminum sections and new high performance glazing would be highly recommended. (Refer to EPC # 6 for costing, as appended at the end of the report).

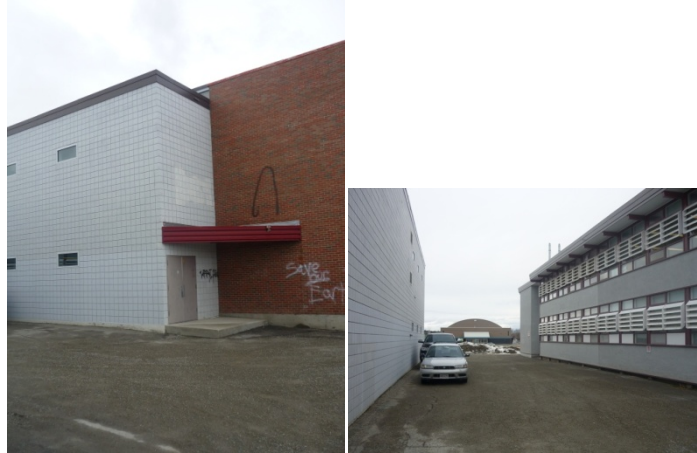
The existing single wythed concrete blocks is insulated from the inside using batt insulation, wood strapping and poly vapour barrier , and finished with drywall. From our observation, there doesn't appear to be any visual indications of failure on this wall construction which would warrant immediate repairs.

It is recommended that a probe test be done to confirm whether the wall cavities are filled with 'Zonolite' insulation.

Thermal scan should also be done to help determine whether there is any air leak which may need to be addressed.

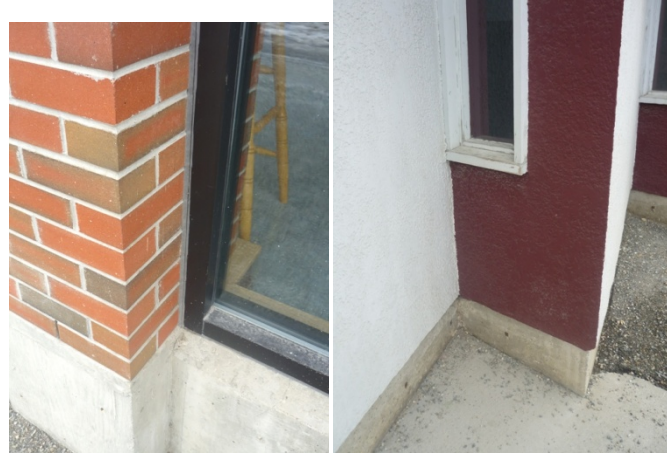
- a. Glazed Aluminum Sections on the North face
- b. Wood Windows at the west side of the building
- c. A handful of aluminum 'punched' windows on the east wall.
- d. All the glazing are sealed double glazed units.

As suggested improvements, replacement of all the windows with thermally broken aluminum sections and new high performance glazing is recommended, in order to improve energy usage both in winter and in the summer.

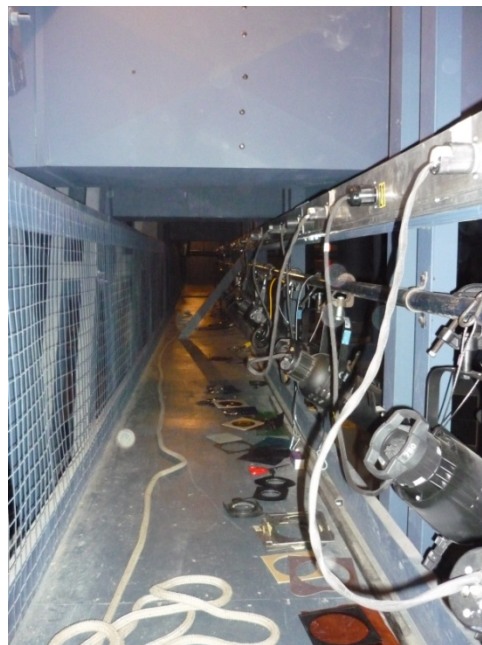
**Catwalk**

- .2 The front of house connector strips and pipe grid area accessible via a cat walk system. Lighting on the catwalk system is incandescent keyless fixture with no wire guards. Lighting control is via the low voltage relay panel.
- .3 Above the stage the light pipe grids are fixed and house lights located above the grid are difficult to access.
- .4 Lighting and scene control is accomplished from the mixing board located in the lighting control booth at the rear of the theatre.

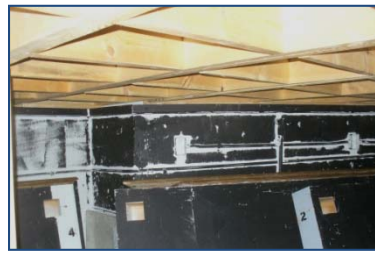
A small section of the ground level above the musician pit was filled in using wood framing (Photo no. 2 & 3).

Photo no. 2 – Floor framing for the in-filled musician pit.

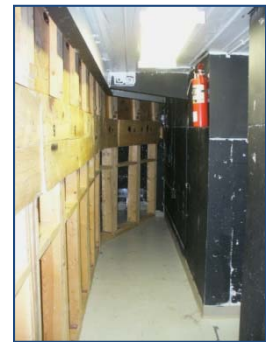
Photo no. 3 – 2x6 stud walls under the musician pit.

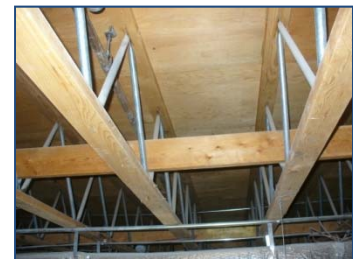
Photo no. 4 – TjL joists framing in the 2<sup>nd</sup> floor of Actors Wing.

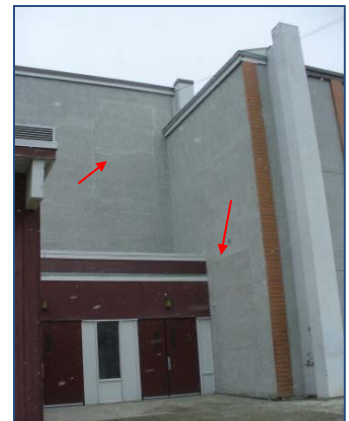
**Photo no. 5 – Cracking & general deterioration of stucco in the west wall.**

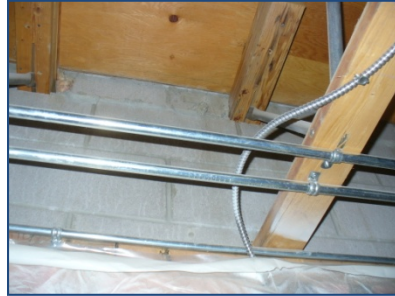
- .1 No major foundation movements and no significant cracking of the block walls or masonry cladding were noticed. Minor cracks in the block wall were expected but were likely covered over by repainting over the years.
- .2 Cracking and general deterioration of the stucco in the west wall of the auditorium was observed. These cracks in the stucco appeared to be due to filling of a wall opening in one location and possible cracks in the block wall that were telegraphing through (Photo no. 5).
- .3 It was noted that the second floor wood trusses of the Actors Wing was set into the exterior block wall where there were no insulation and vapour barrier. Condensation could easily occur and causing deterioration of the wood members. Signs of water stain in the wood chords and in the ceiling tiles were observed (Photos no. 6 & 7).

Photo no. 6 – Block wall section in joist space was un-insulated & in direct contact with the wood joists, which shows signs of water stain possibly from condensation.

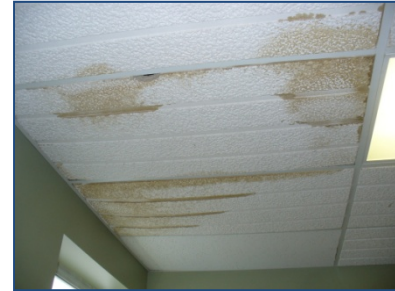
Photo no. 7 – Water stain in ceiling tiles indicating possible leaks from above. Further investigation is required to determine cause.

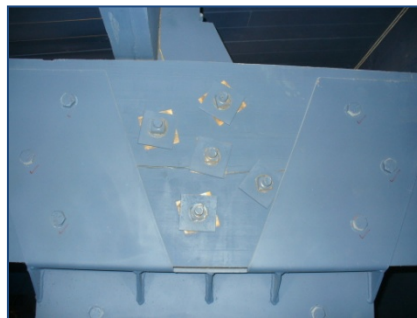
- .4 According to the information given the roof of the auditorium (original gymnasium) has had a failure about 4 years ago. Details and exact mode of the failure was not available to us. However based on our observation the remedial work appeared to be primarily on the heavy timber trusses, some of which had been extensively reinforced. Such remedial work apparently included:
- Strengthening most of the truss panel point connections or retightening of the bolts (Photos no. 8 & 9).

Photo no. 8 – Truss panel point connection bolts had been retightened.

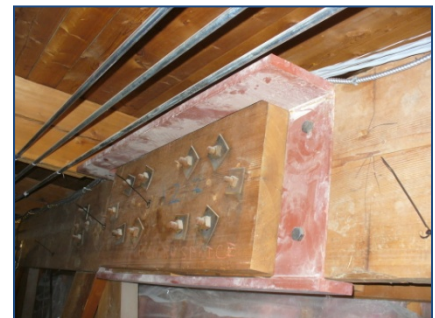
Photo no. 9 – Remedial work in strengthening truss top chord connections.

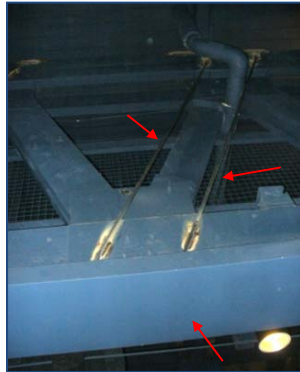
- Addition of steel tension rods in the first and second diagonal web members (Photo no. 10).

**Photo no. 10 – Truss web member reinforced with steel tension rods. Also noted bottom chord was reinforced with additional member.**

- Installing additional wood member to the bottom chord of some trusses (Photo no. 10). Some trusses were not strengthened (Photo no. 11).

- .1 Original design snow load was about 50% less than the current building code requirement.
- .2 The design dead load has increased significantly due to increase in superimposed loads from the addition of service platforms and catwalks, lighting and acoustic equipments, and upgraded roofing assembly.
- .3 The combined maximum live and dead loads could cause failure of the original trusses with the failure mode initiating from the bottom chords and then the diagonal web members.
- .4 Provided the remedial work was completed properly the strengthened trusses should meet current code requirements. However we are concerned with the trusses that have not received reinforcing to its bottom chord. We believe such work is required for every truss.

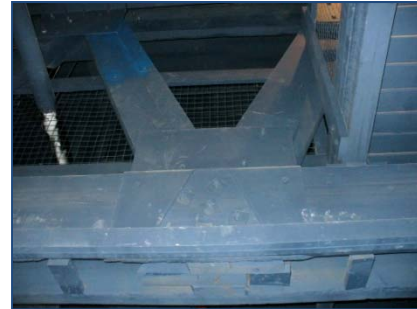
**Photo no. 11 – Timber truss not strengthened.**

These loading increases have rendered the roof framing in the auditorium significantly under designed. Although some roof trusses had been strengthened following a failure but some have yet to be strengthened.

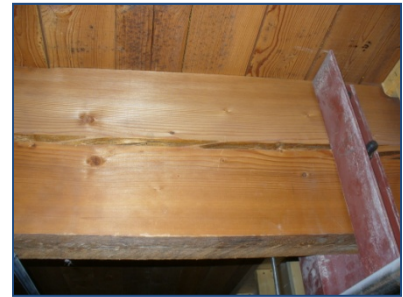
- .5 The secondary framing members of the auditorium roof appeared performing satisfactorily. Many of the timber beams showed significant checking and warping due to drying and shrinkage that are typical for heavy timber and should not be cause for concern at the current state except where bolted connections intersecting the cracks where it should be monitored (Photo no.12).

**Photo no. 12 – Significant checking & warping of the secondary timber beams. Bolted connection of steel angle hangers through the crack**
